Report on  
Preliminary Geotechnical Investigation

Proposed Train Support Facility  
Woodlands Close, Hexham

Prepared for  
QR National

Project 39798.08  
November 2012

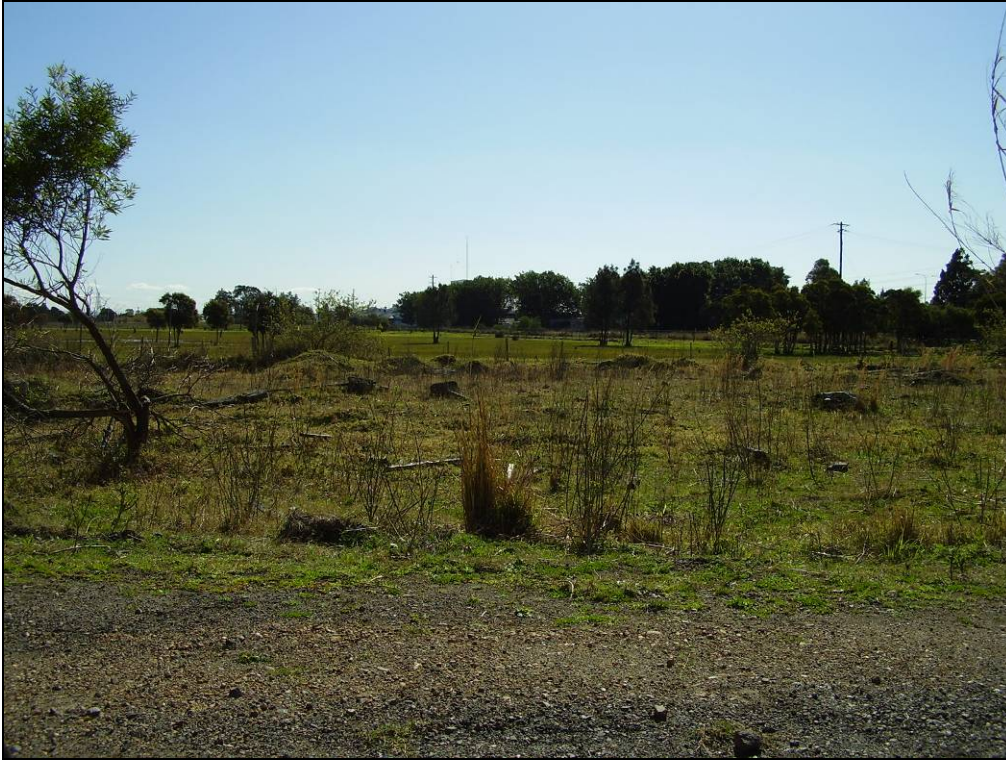
Filling was evident in the central and eastern portions of the site. Surface observations indicated that coal washery reject was the predominant filling type (refer Figure 1).

**Figure 1: Filling stockpiles in the eastern portion of the site**

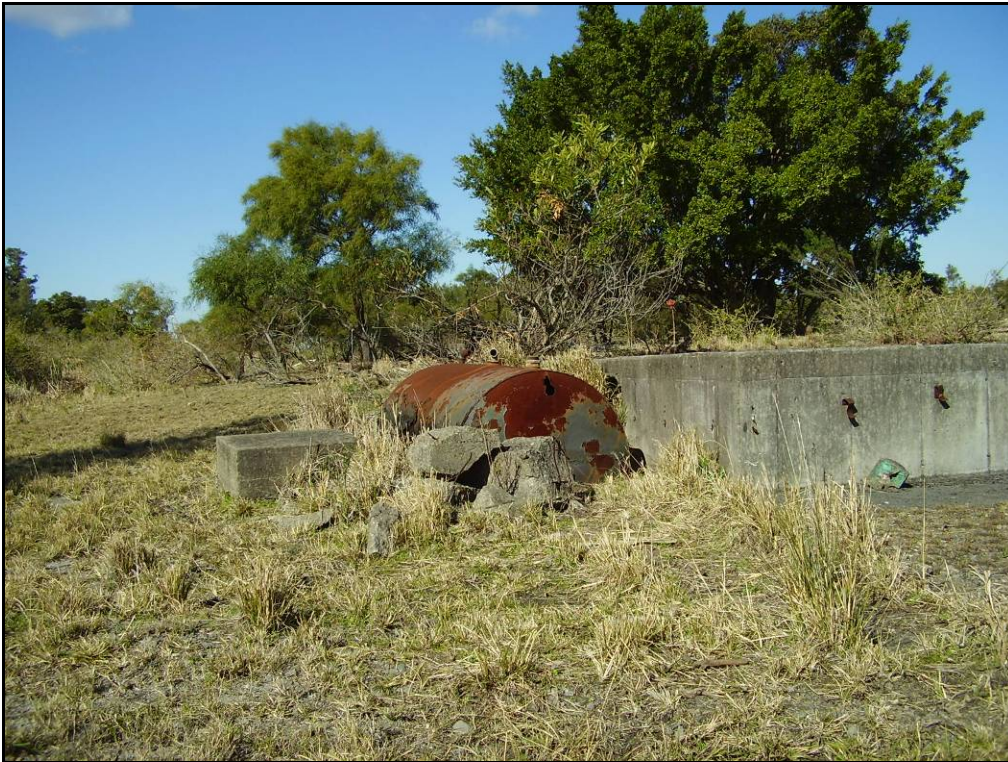
- A former storage tank was located in the central portion of the site near CPT TP15. Some minor surface staining was observed in the vicinity of the tank (refer Figure 2);
- Other stockpiles of filling observed onsite comprised terracotta roof tiles (refer Figure 3), fibro (possibly containing asbestos – Figure 4) and other deleterious material such as concrete, bricks and timber (Figure 5);
- Concrete slabs and piers, relating to the former building and conveyors, were observed across the southern parts of the site.

**Figure 2: Storage tank observed in the central/eastern portion of the site**

- Presence of building materials (rubble) within filling (possible asbestos) in the southern part of the site (former coal preparation plant);
- Presence of fuel storage area (Figure 2) with some minor staining of adjacent ground surface;
- Presence of coal chitter and filling covering generally the southern parts (Figures 4 and 5) of the site;
- Scattered stockpiles of rubbish including fuel drums generally adjacent to access tracks;
- The results of PID Screening on soil samples are shown on some borehole logs in Appendix B and generally suggest the absence of gross volatile hydro-carbon impact;
- Groundwater was observed in the boreholes; observation of the water suggested the absence of visual or olfactory contamination (ie visible staining and odour). It is noted that groundwater was not sampled or analysed to confirm chemical condition.

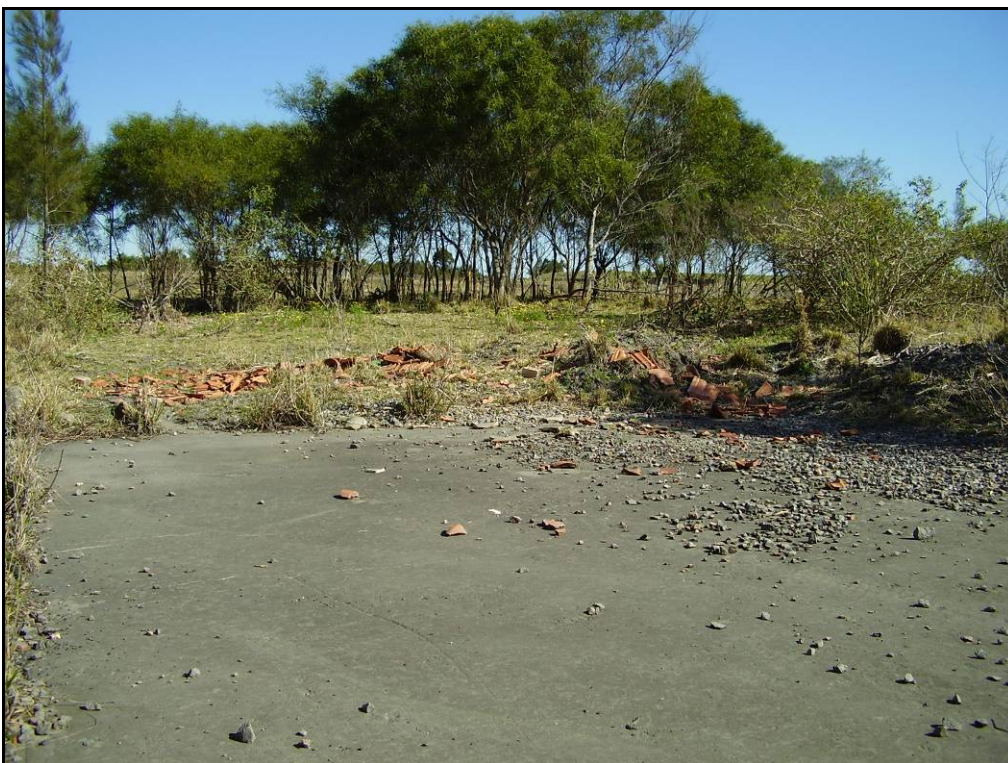
**Figure 3: Scattered stockpile of terracotta roof tiles**

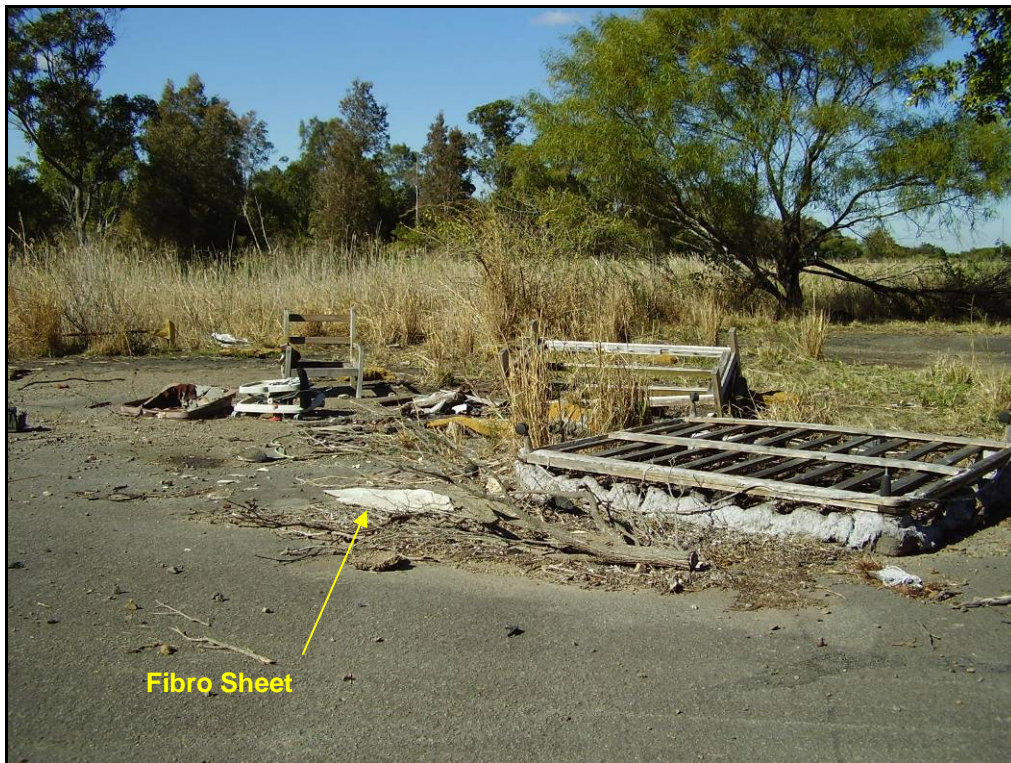
**Figure 4: Scattered filling over a paved area in the central part of the site**

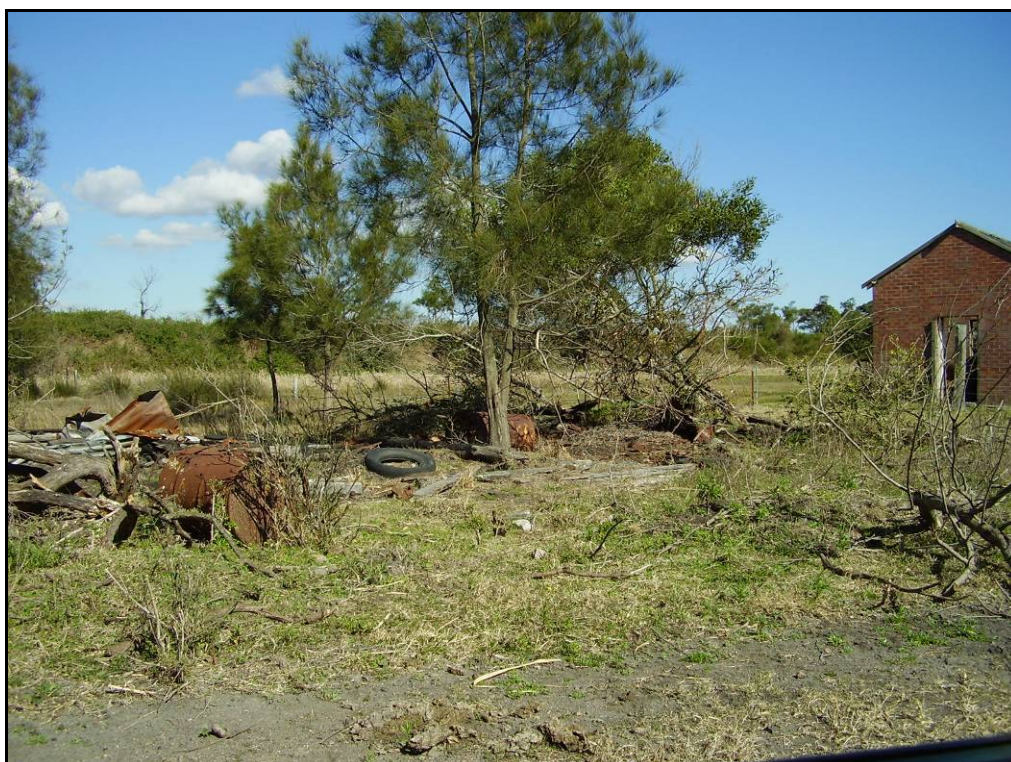
**Figure 5: Scattered stockpile of timber, tyres and 44 gallon drums**

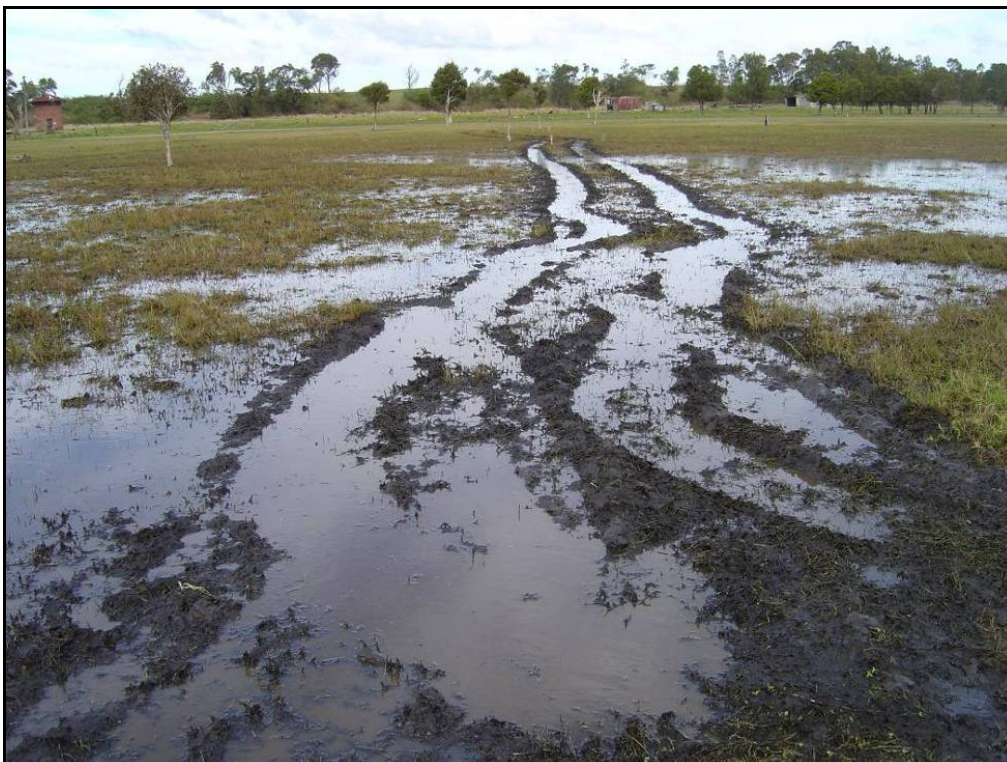
Surface water was ponding at the time of field investigations in July to September 2007 and was generally 0.1 m to 0.4 m in depth. The water was observed over the central low-lying areas of the site (ie CPT 2 to 10) and Bore TP35. The area was not accessible to standard vehicles and a specialised light weight "all terrain" vehicle was required to gain access to this section of the site (refer Figure 6).

**Figure 6: General site figure showing low lying areas**

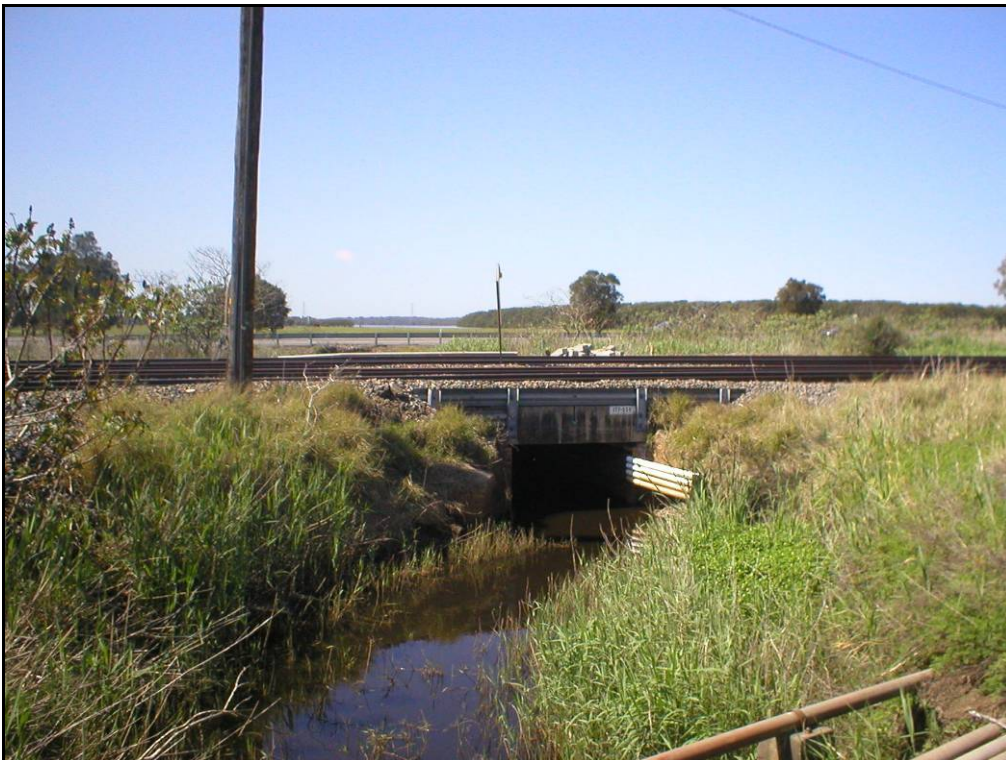
One major drain is situated at the northern part of the site. The drain flows from west to east via an unlined grassed channel which appears to have been excavated below former ground levels. The drain passes beneath the rail embankment at Ch 177.060 km via a concrete culvert (refer Figure 7). Water was ponding in the base of the drain.

**Figure 7: Culvert beneath existing track at Ch 177.060 km**

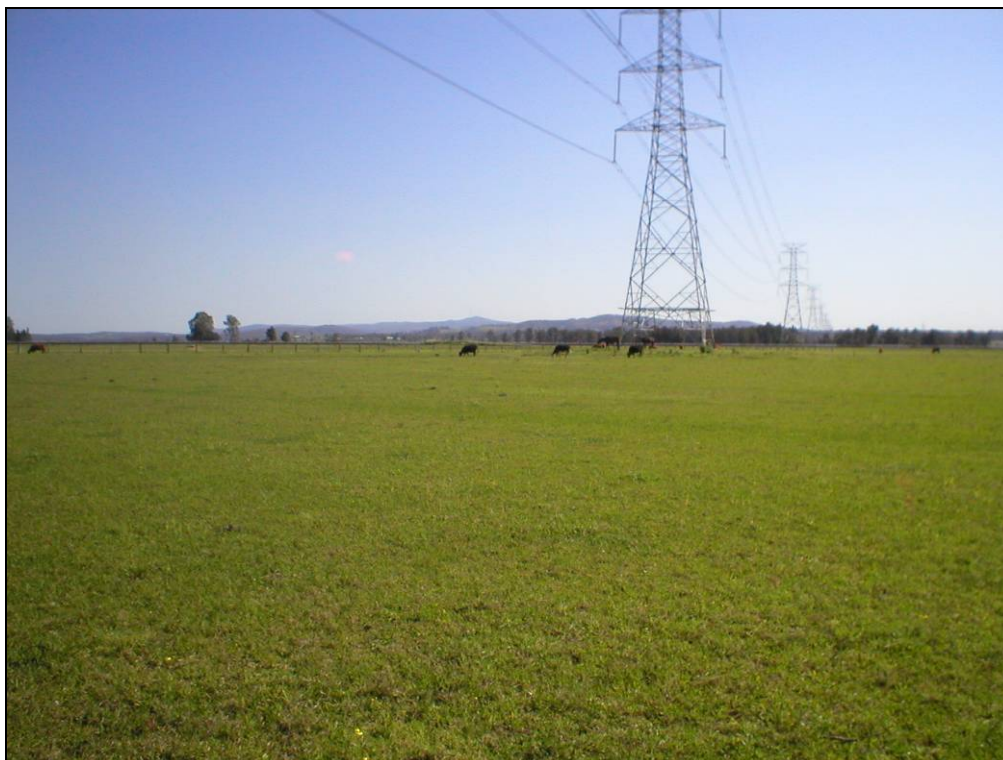
The Chichester Pipeline passes through the site together with overhead power lines and drainage channels.

**Figure 8: Western part of the site**

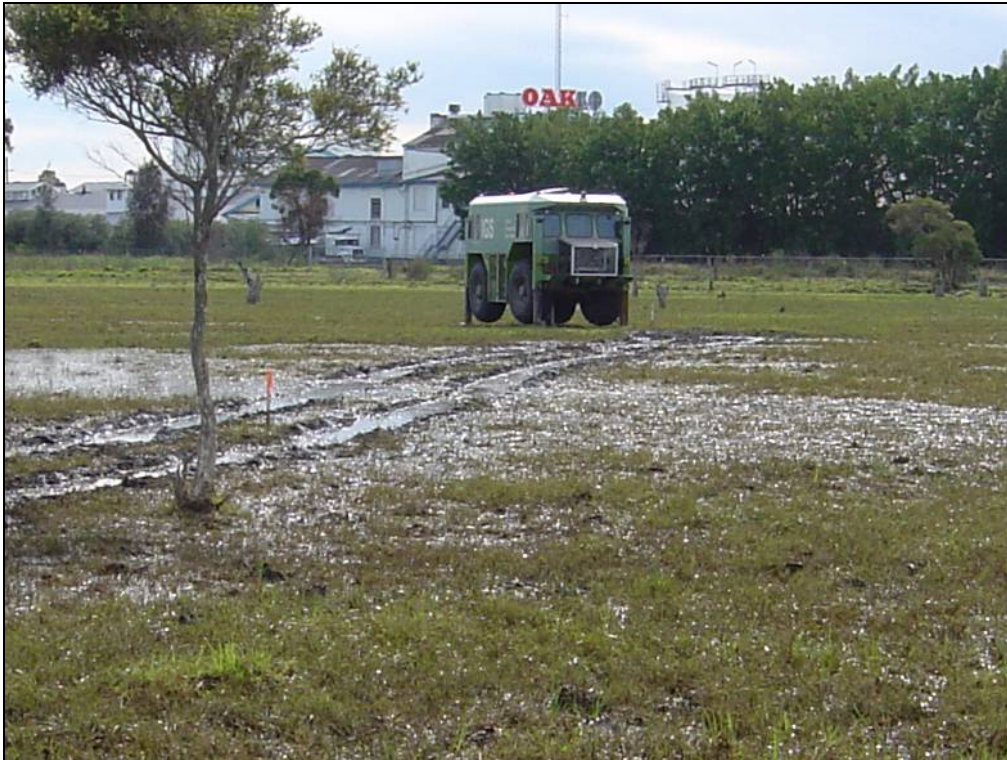
The standard tests were carried out using a custom-built, truck-mounted CPT rig, with centrally located hydraulic rams. The piezocones were carried out with an 'all terrain' CPT rig capable of accessing the soft / wet areas of the site (refer Figure 9 below). The cones were advanced at a constant rate of approximately 20 mm / second and a digital data acquisition system recorded cone tip resistance, friction sleeve resistance, dynamic pore pressure (only in piezocone), inclination from vertical and encoded depth at measurement intervals of 20 mm.

**Figure 9: CPTu testing within low lying parts of the site using “all terrain” rig (2007)**

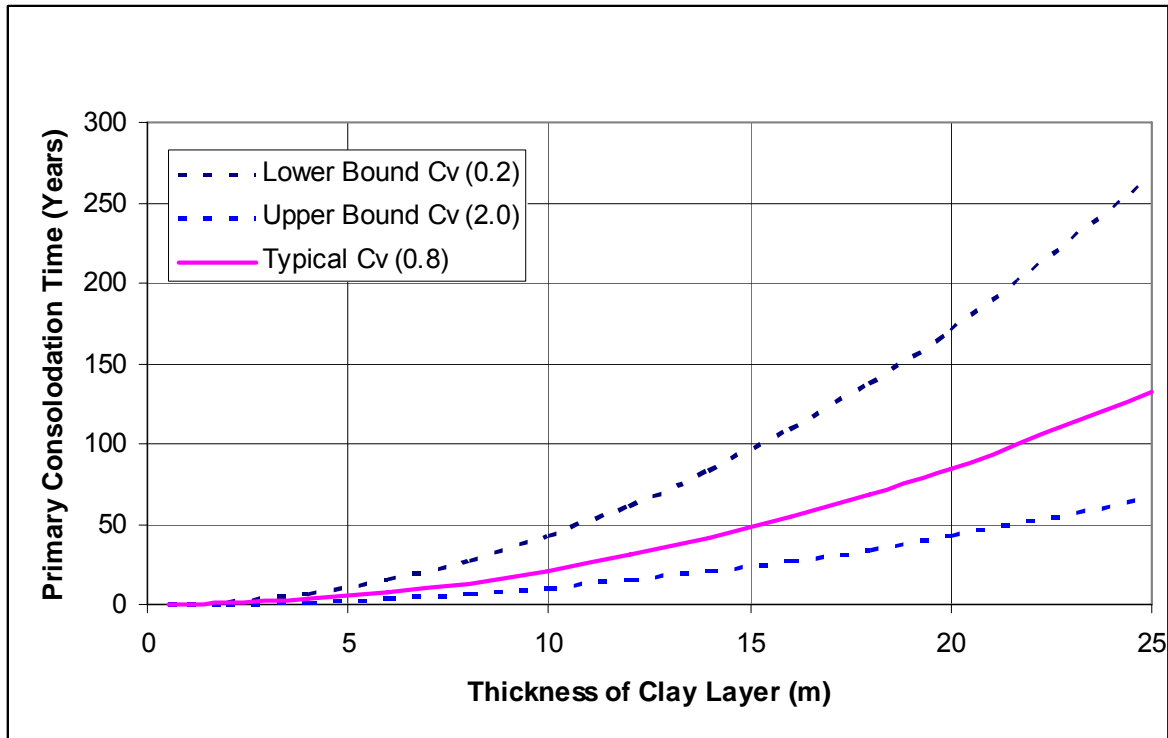
The time for the settlement of clay layers to occur can be difficult to predict, and will vary with the thickness of the clay, the coefficient of consolidation and whether there are any intermediate drainage layers (eg sandy layers). The theoretical time for 95% primary consolidation to occur is shown in Figure 10 plotted against clay thickness and the  $c_v$  values given in Table 10.

**Figure 10: Primary Consolidation**

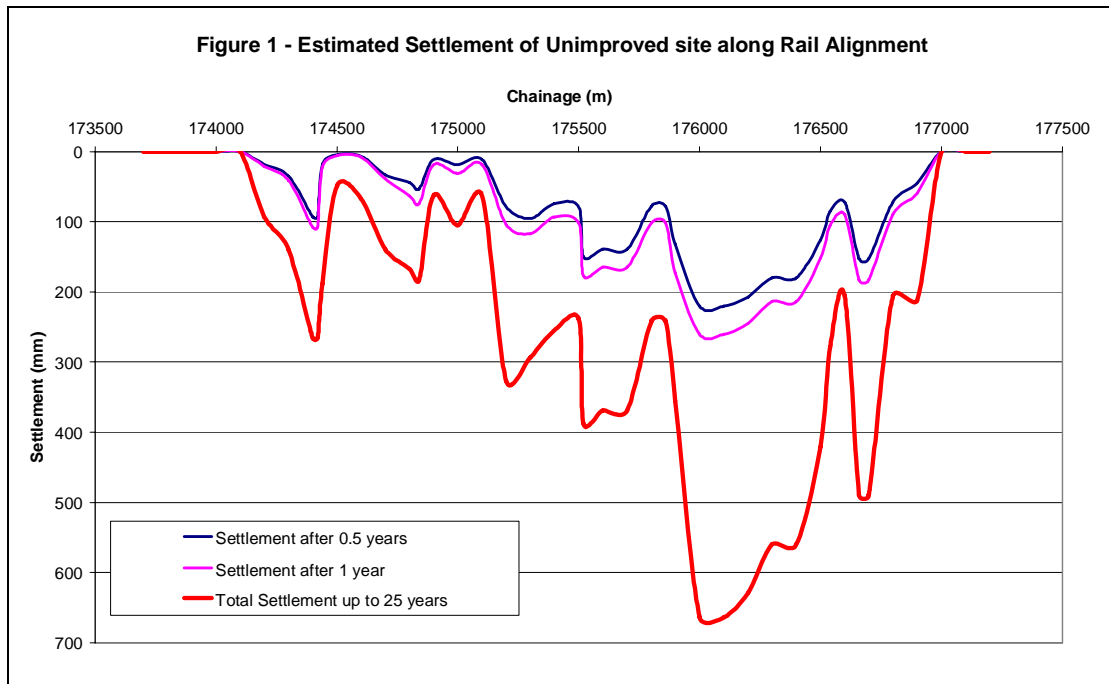
At each CPT location a time-settlement plot was determined for an unimproved site. Figure 1 shows the settlement estimates at 0.5 years and 1 year following placement of filling and are compared to the total estimated settlement over 25 years.

Based on the above plots, the largest expected settlement along the rail alignment will be between Ch 176000 m and 176700 m. This area correlates to the area where pre-existing filling has not been placed and the proposed fill height is greatest. This area is also situated in the area where the underlying clays are weaker in strength.

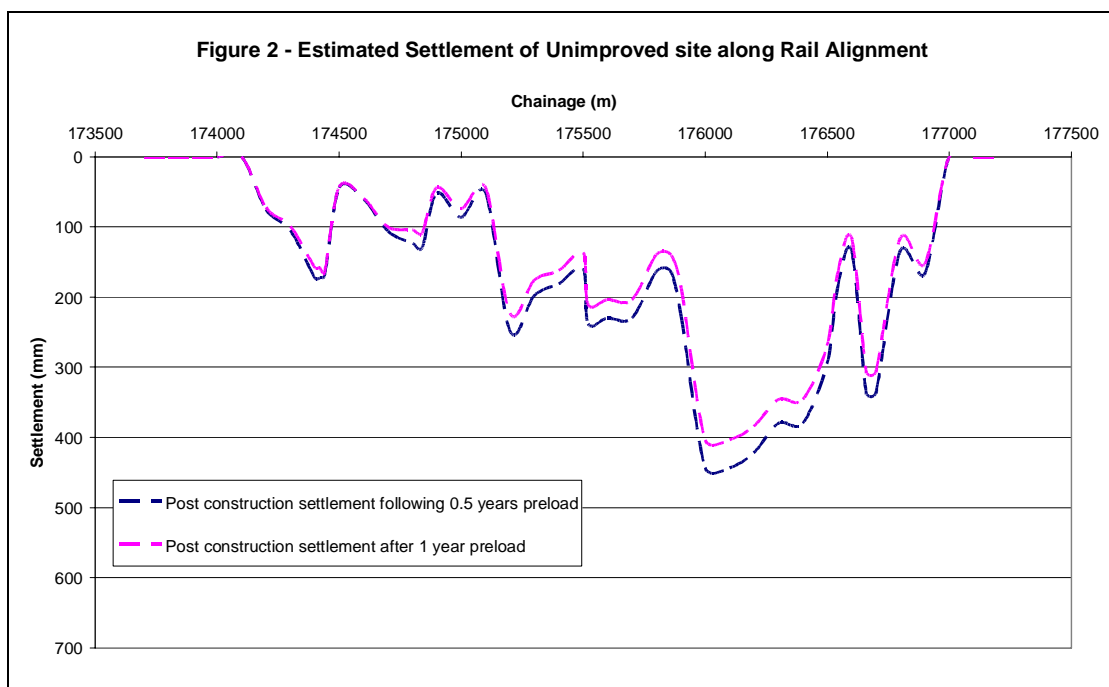
Figure 2 shows the post construction (residual) settlement of the rail embankment up to 25 years after the initial settlement

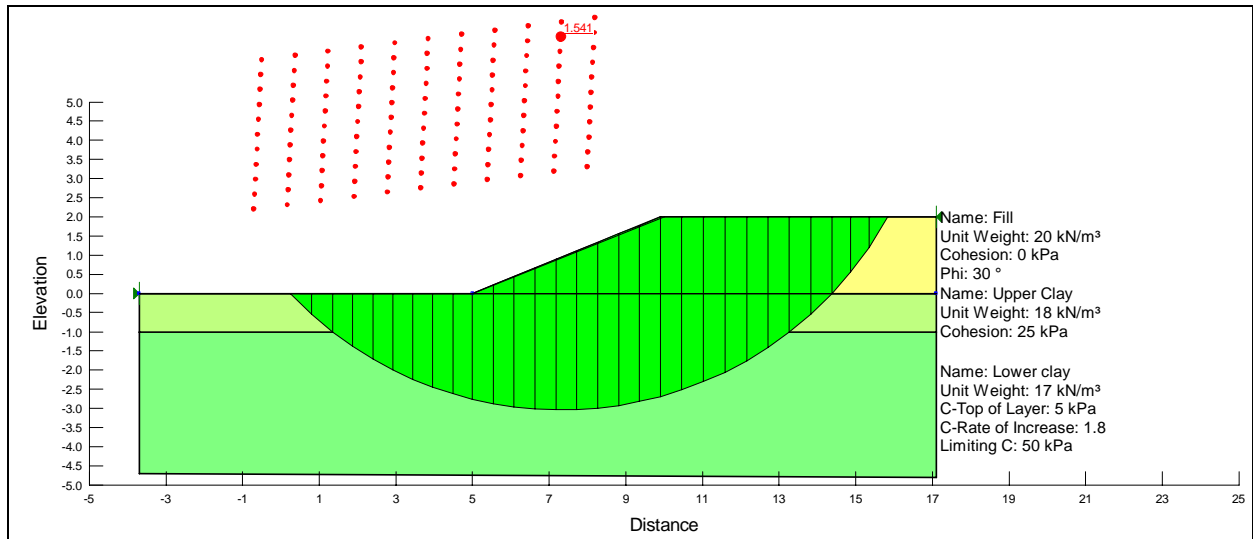
The results of the analysis are shown in Figure 3 below and indicate that the factor of safety against slope failure during preload is 1.5 which is considered satisfactory for no load at crest.

**Figure 3: Results of Stability Analysis (no ground improvement, no load at crest)**

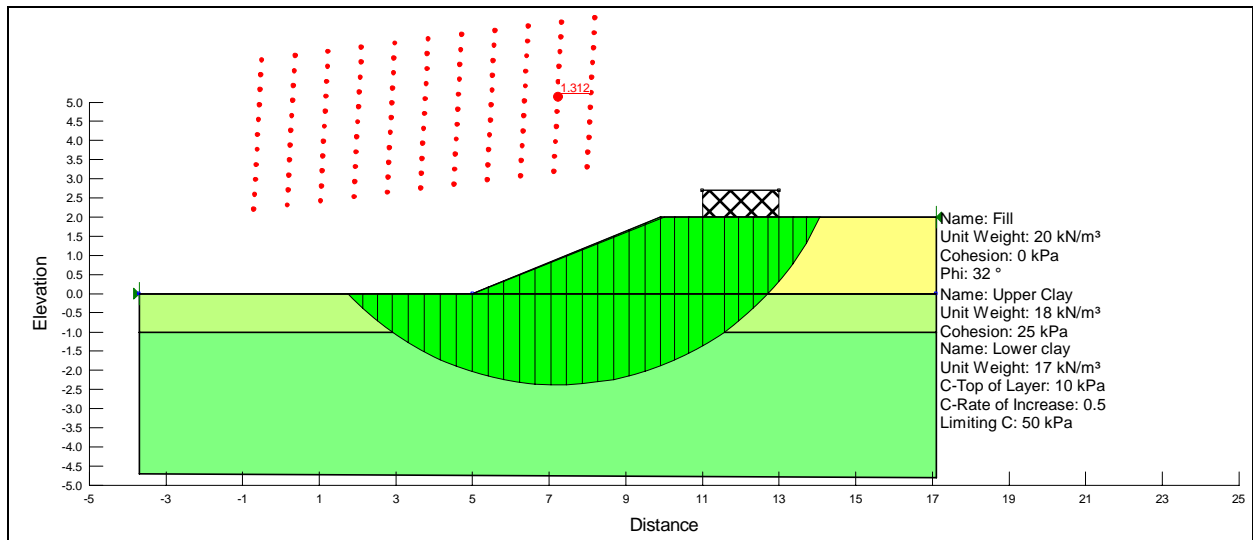
The results of the stability analysis are presented in Figure 4 and indicate that the factor of safety following 1 year preload is about 1.3.

**Figure 4: Results of Stability Analysis (following 1 year preload)**

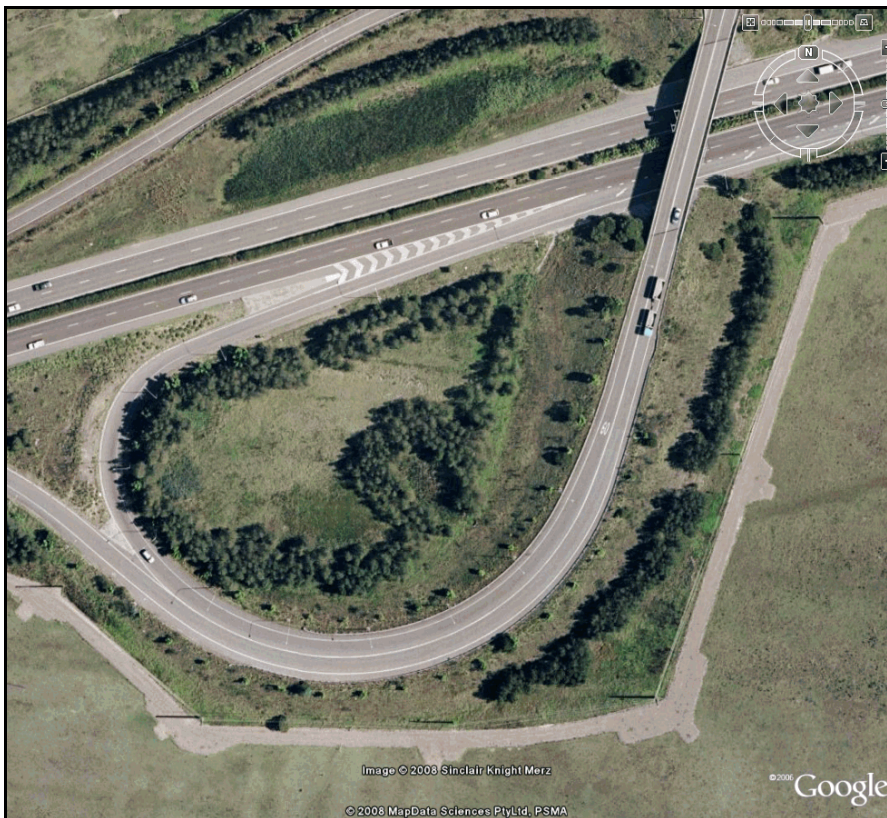
The existing Tarro interchange comprised a concrete bridge spanning over the New England Highway with an earth-filled embankment on either end. The site of the geotechnical investigation is situated at the southern abutment (Figure 1). The earth filled embankment is about 8 m high and has grassed batters of between 2.5H:1V to 3H:1V. A row of semi mature trees is located at the eastern toe of the fill embankment.

**Figure 1: Southern Abutment of Tarro Interchange**

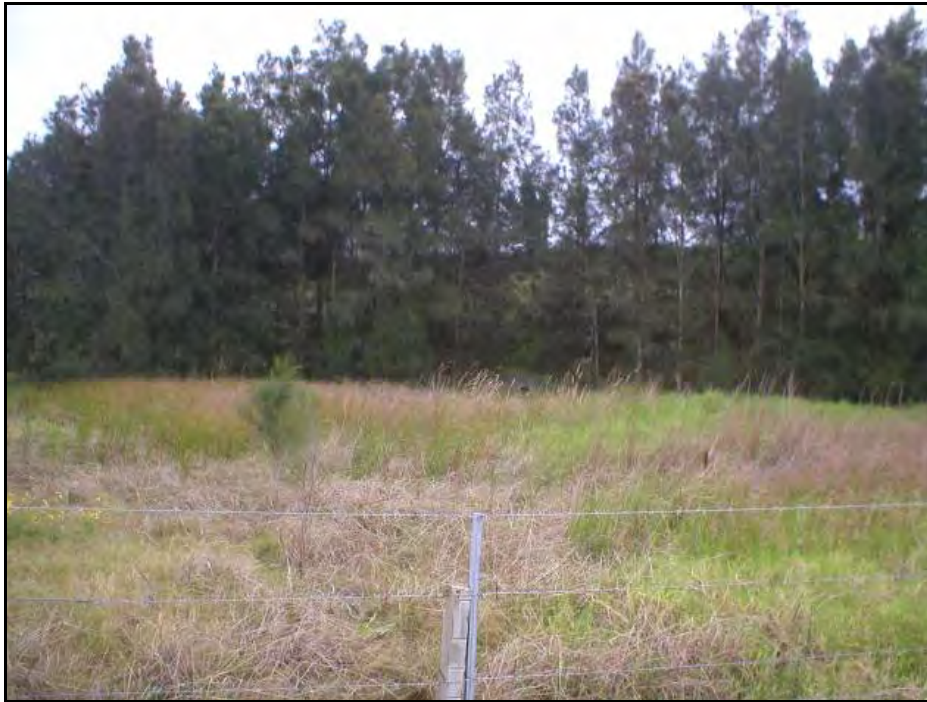
The area situated between the interchange and Woodlands Close comprises relatively flat grassed paddocks. The surface was saturated at the time of the investigation resulting in difficulties gaining access to test locations with rubber tyred vehicles. The Chichester pipeline bisects the access road in a north-south direction.

**Figure 3: Area between gravel access road and the eastern side of the interchange embankment**

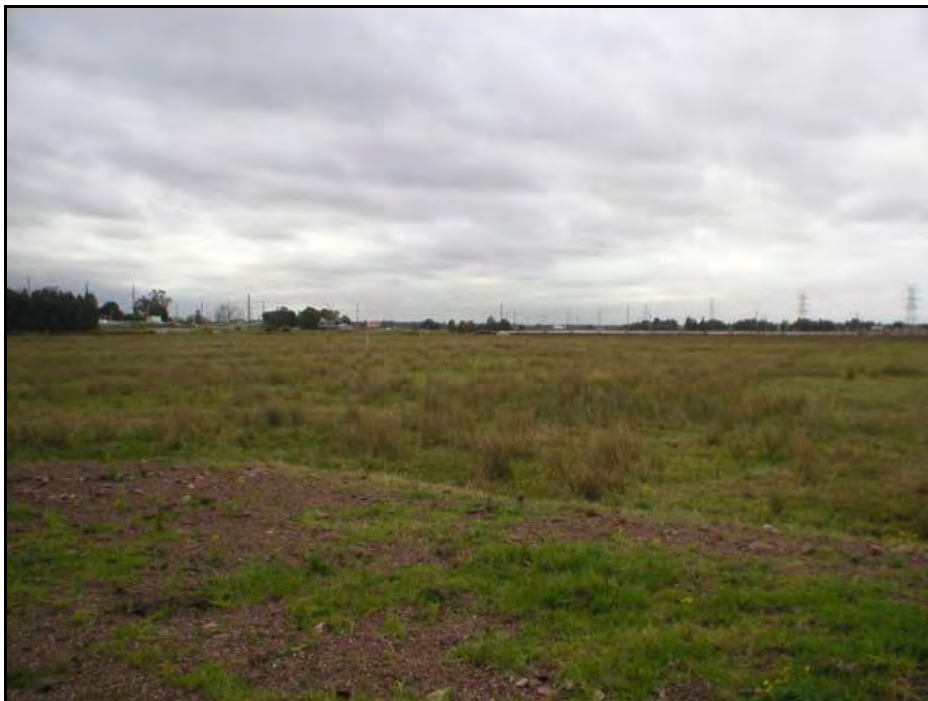
**Figure 4: Low lying grassed paddock between the Interchange and Woodlands Close (Old Maitland Road)**

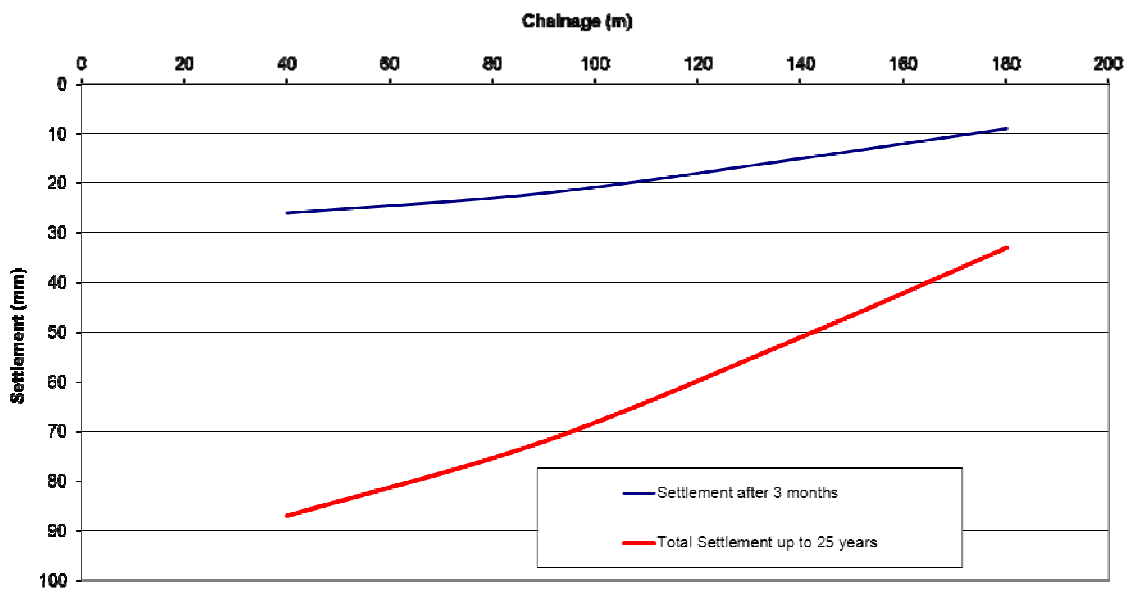
**Figure 1 - Estimated Settlement of Unimproved site along Road Alignment**

Based on the above plot, the largest expected settlement along the road embankment will be between Ch 35 m and 80 m. This area correlates to the area where the depth of proposed filling is greatest (about 10 m high) which would subject a load of about 200 kPa onto the foundation soils.

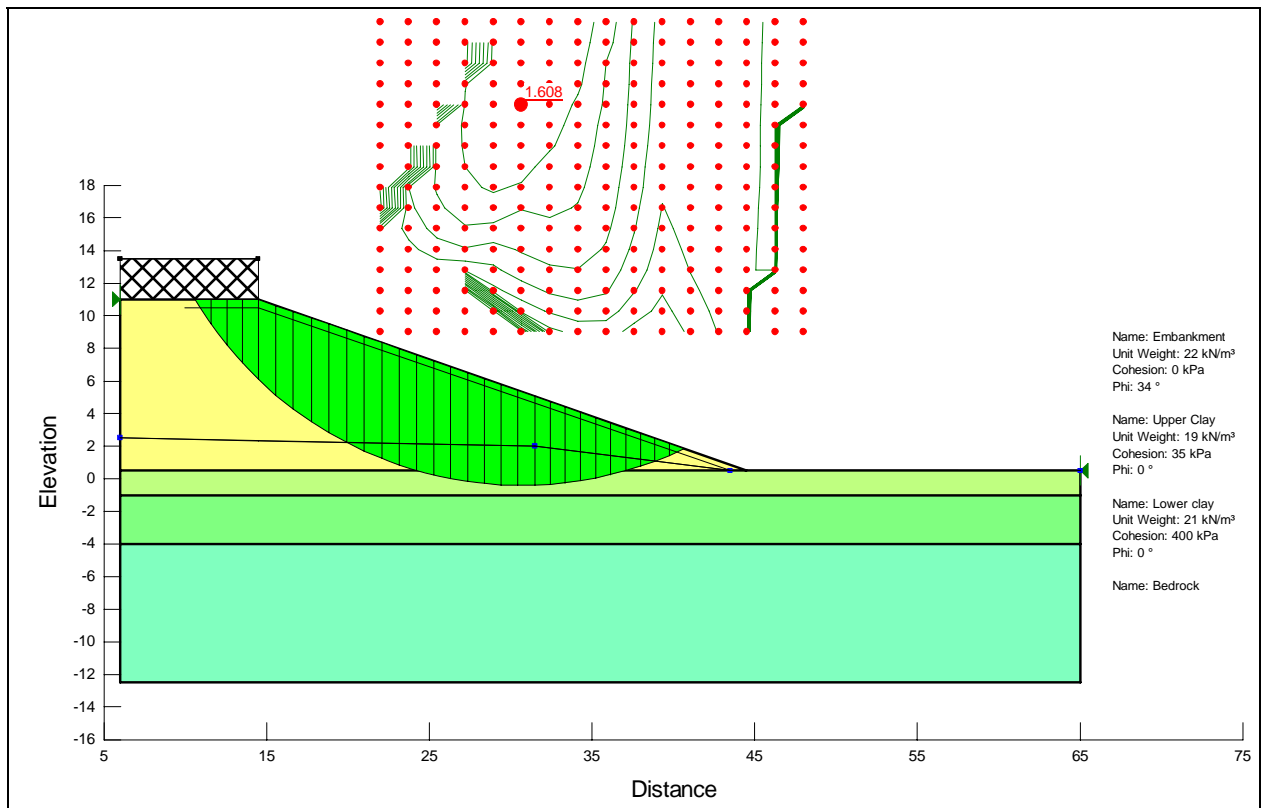
The stability was reanalysed for a batter slope 3H:1V. The results of the analysis indicated a factor of safety of 1.6, as shown in Figure 2, which was considered acceptable.

**Figure 2: Results of Stability Analysis (3H:1V batters)**

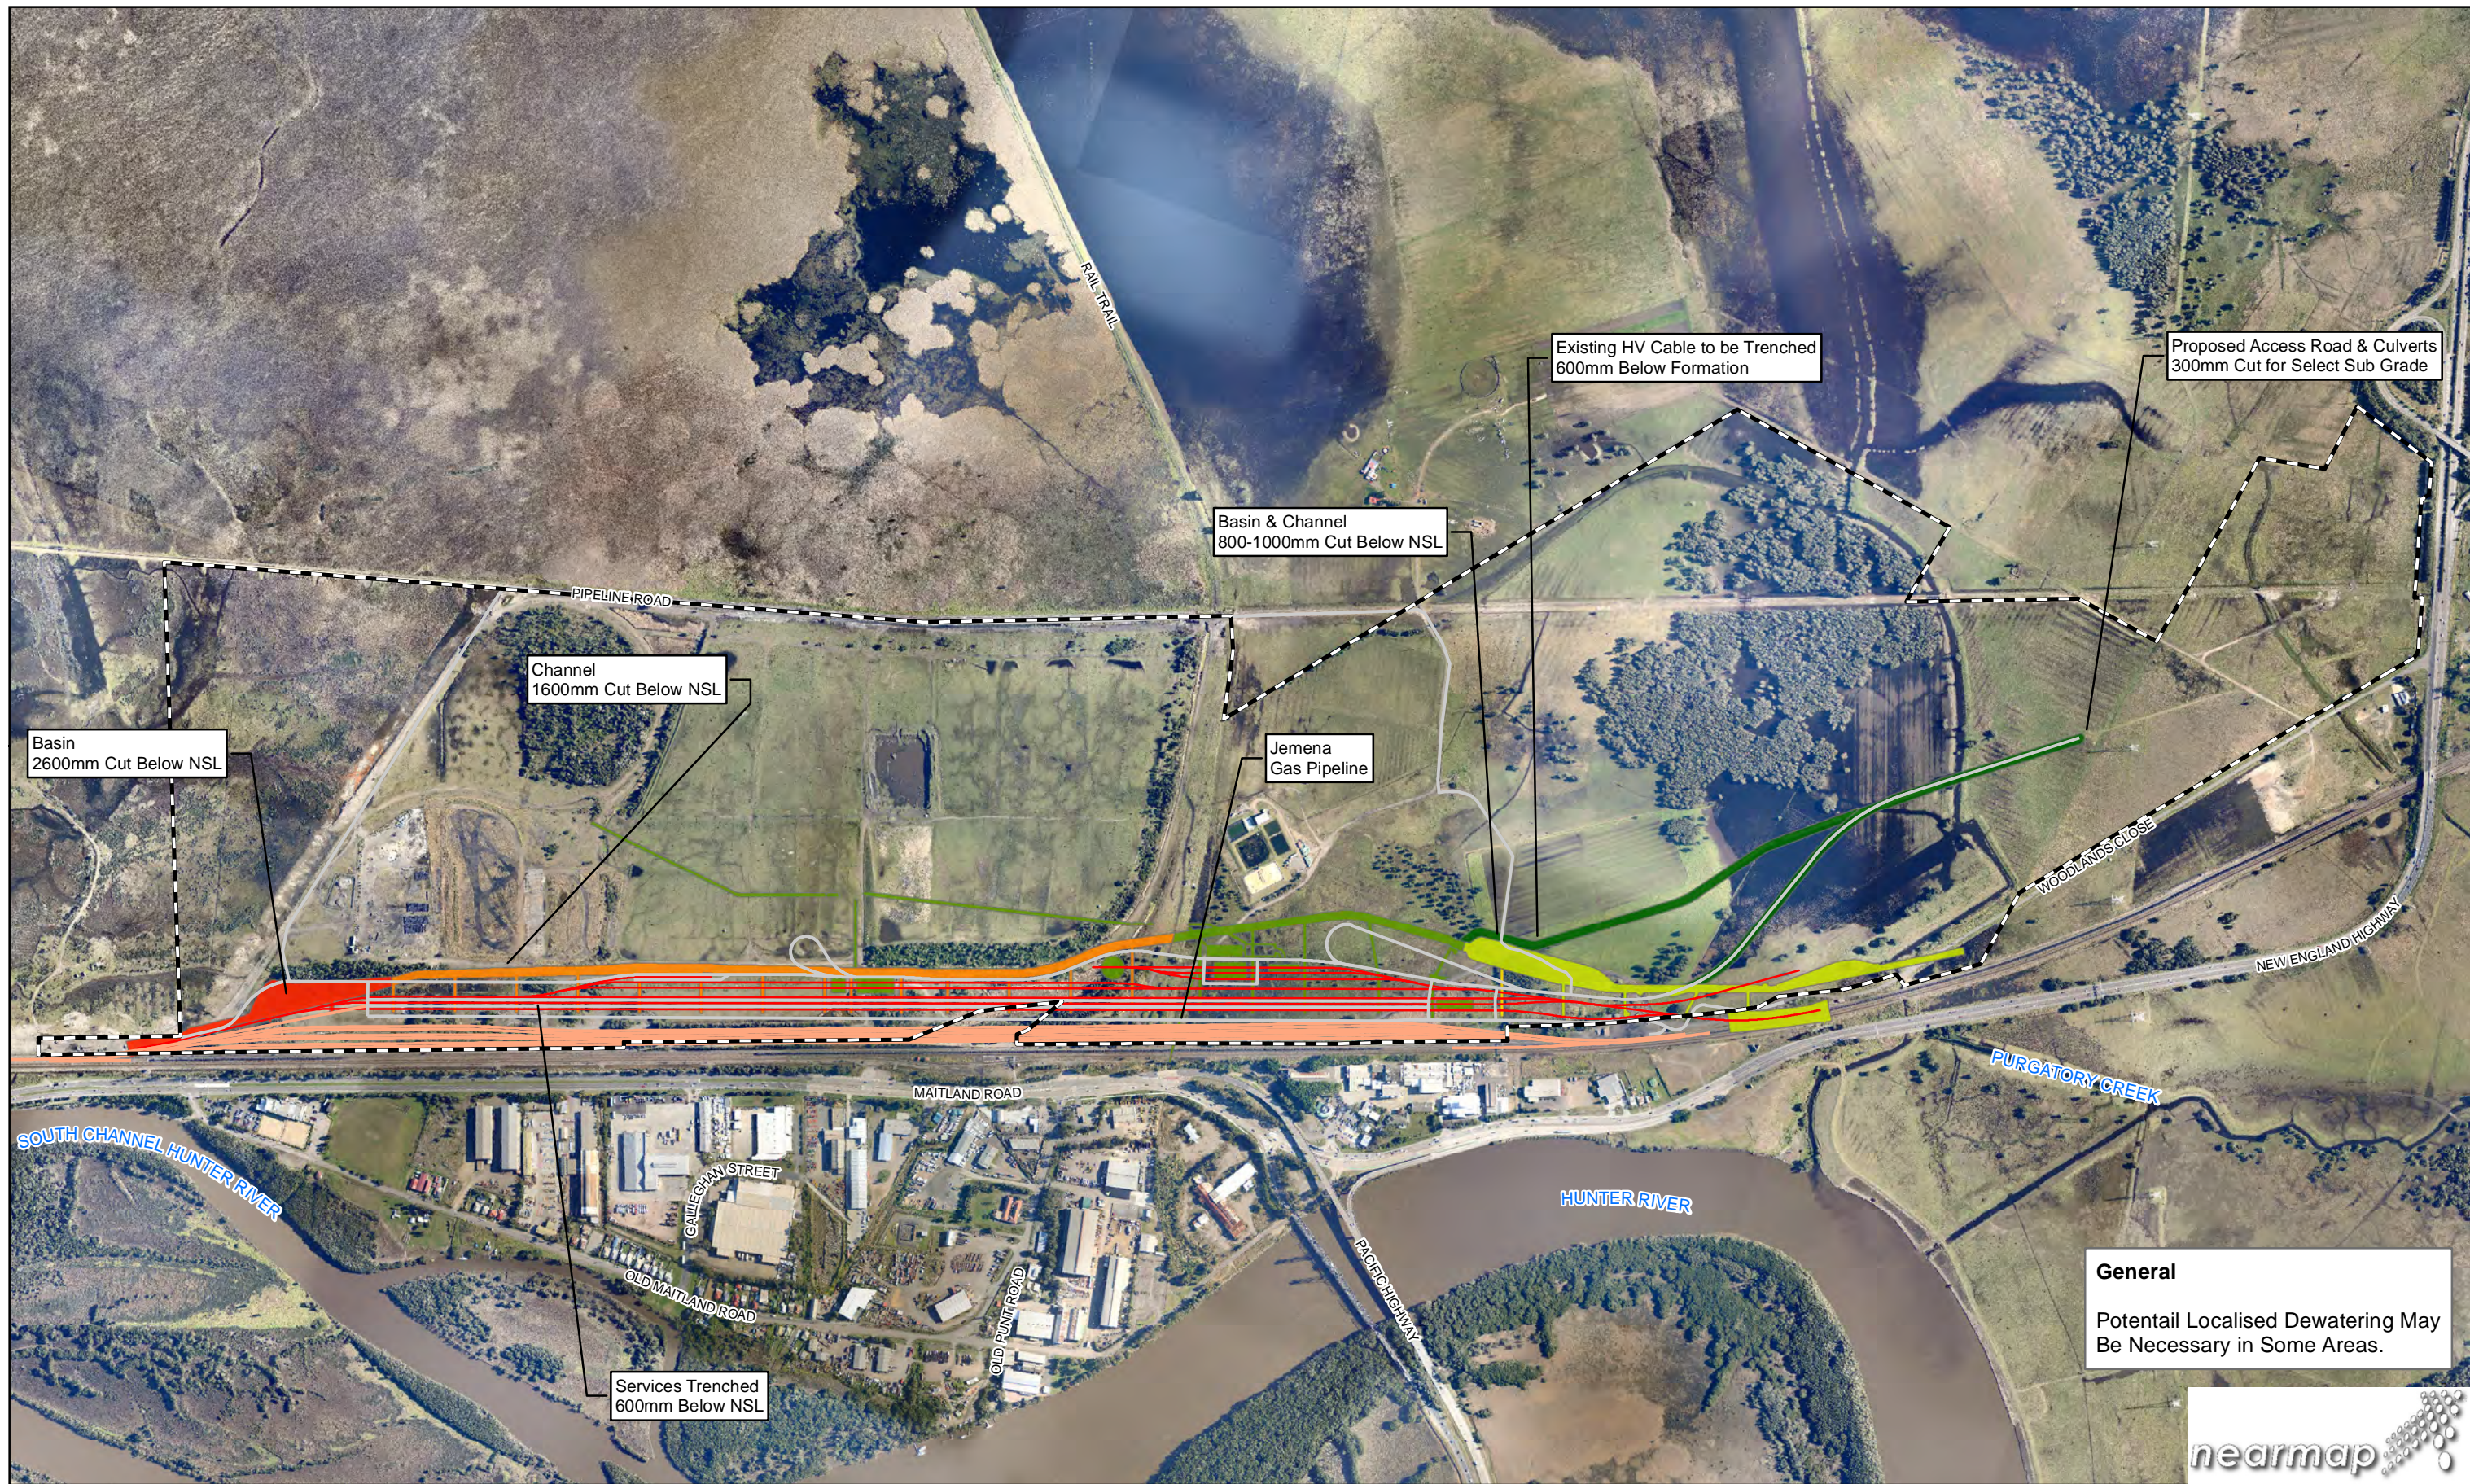
PROJECT No: 39798.08  
 DRAWING No: 1-3  
 REVISION: 0

TITLE: **Geological Section A-A'**  
**Proposed Train Support Facility**  
**Woodlands Close, Hexham**
