Report on  
Effluent Disposal Assessment

Proposed Train Support Facility  
Woodlands Close, Hexham

Prepared for QR National

Project 39798.07  
November 2012

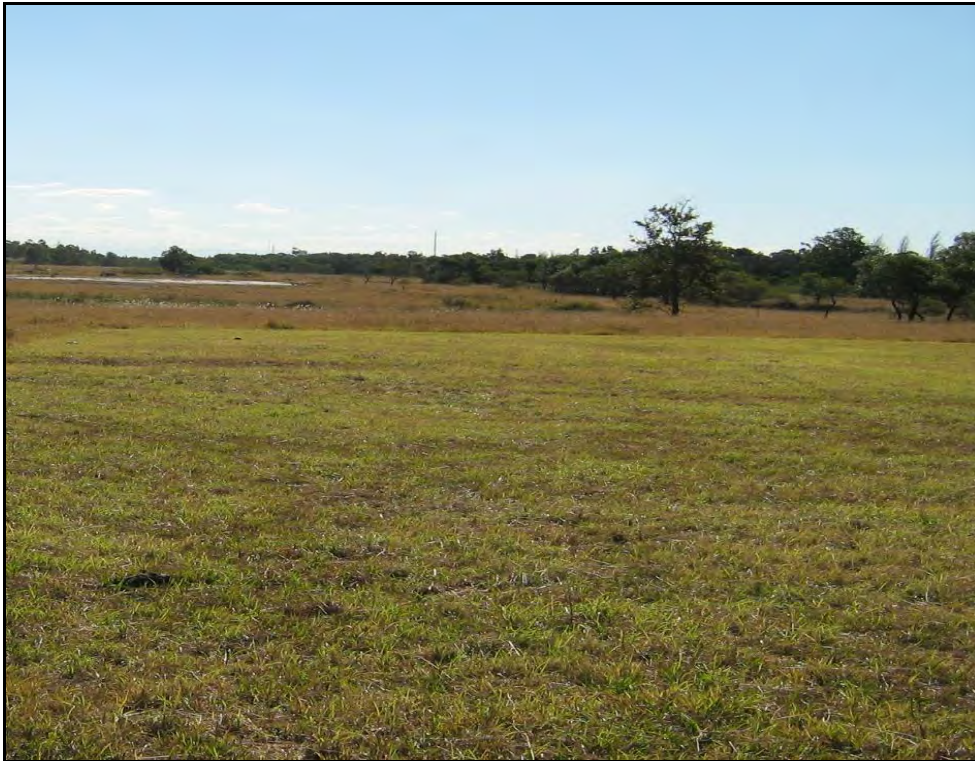
At the time of the assessment in 2008, the proposed effluent irrigation area comprised predominantly open grass land, with two shallow drainage channels/intermittent waterways which drain in an approximately west to east orientation. A concrete hardstand and concrete footings are located in the central portion of the site and are associated with the former coal preparation plant. The concrete hardstand and associated footings occupy an area of about 2500 m<sup>2</sup> within the proposed effluent disposal area. Figure 1 below shows the open grass land in the southern portion of the site looking north towards a drainage channel and the concrete hardstand in the background.

**Figure 1: View to the north of the grassed area sloping toward the drainage channel in southern portion of the site, with the concrete hardstand in background (June 2008)**

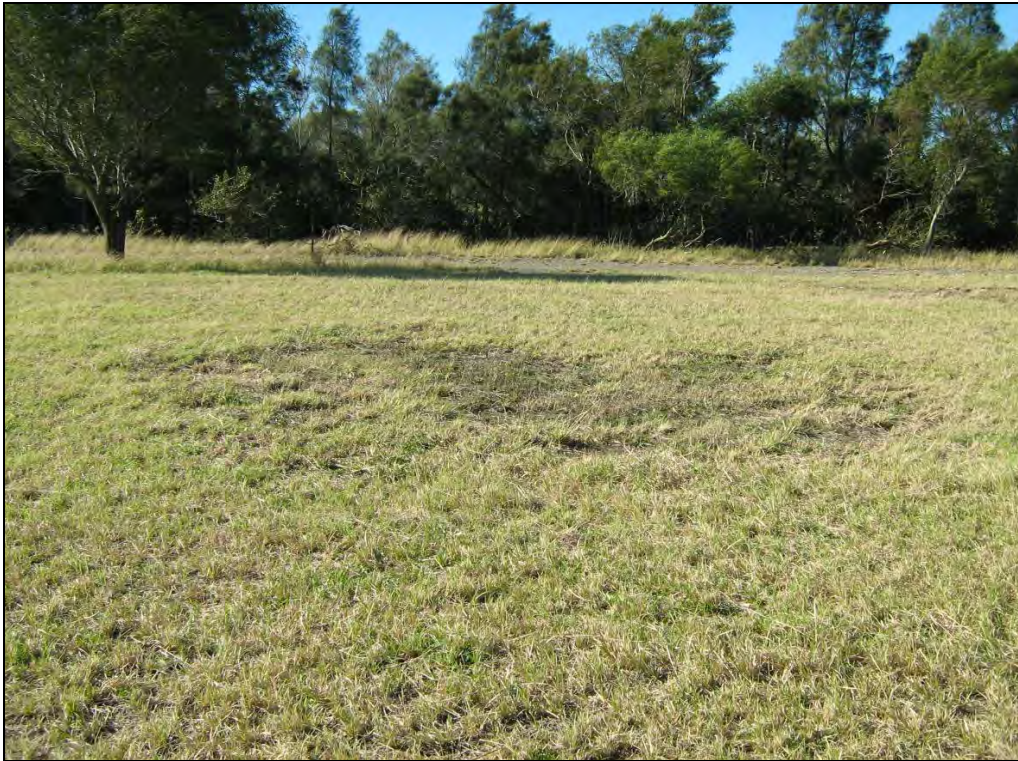
Site observations indicate that overland surface water within the southern and central portion of the proposed effluent irrigation area would predominantly flow toward the two drainage channels. Localised surface depressions were observed in the southern and central portion of the site (Figure 2). Site observations indicate that overland surface water ponds in the depressions following rainfall.

**Figure 2: Localised surface depression in southern portion of the site (looking east June 2008)**

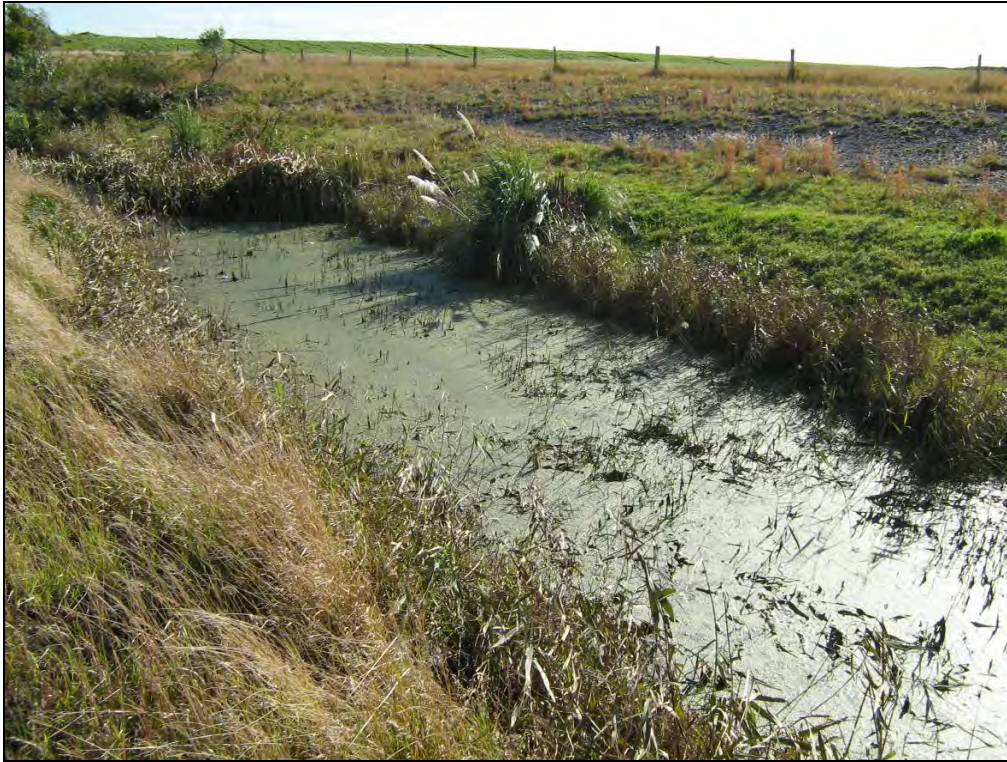
The drainage channels fall to the west of the proposed effluent irrigation area. It is noted that no off-site drainage routes (ie culverts, overflow channels) were observed for the drainage channels. Figure 3 below shows the northern drainage channel, partially filled with surface water and vegetated with reeds and algae at the water surface.

**Figure 3: Northern drainage channel (looking west June 2008)**

- Earthworks to re-contour and fill drainage channels and redirect surface water flow around the proposed effluent irrigation area (to meet recommended buffer distances);

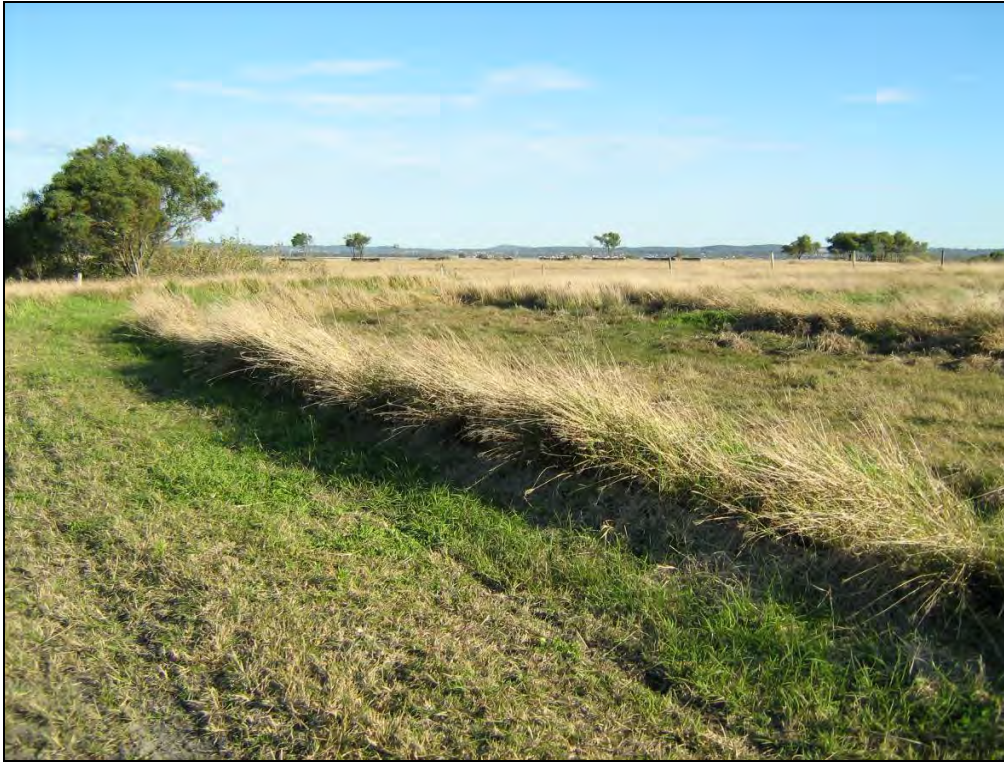
The northern portion of the site is located downslope of the Dairy Farmers' effluent irrigation area. The site observations indicate this area of the proposed effluent disposal area is susceptible to run-on and seepage. Observations also indicate surface water would drain in an easterly direction towards either the small dam or drain to the east of the proposed effluent irrigation area. Figure 4 below shows the shallow dam in the northern portion of the site, which was observed to be vegetated with grass and contain shallow ponded water at the time of field work.

**Figure 4: Shallow dam in northern portion of site (June 2008)**

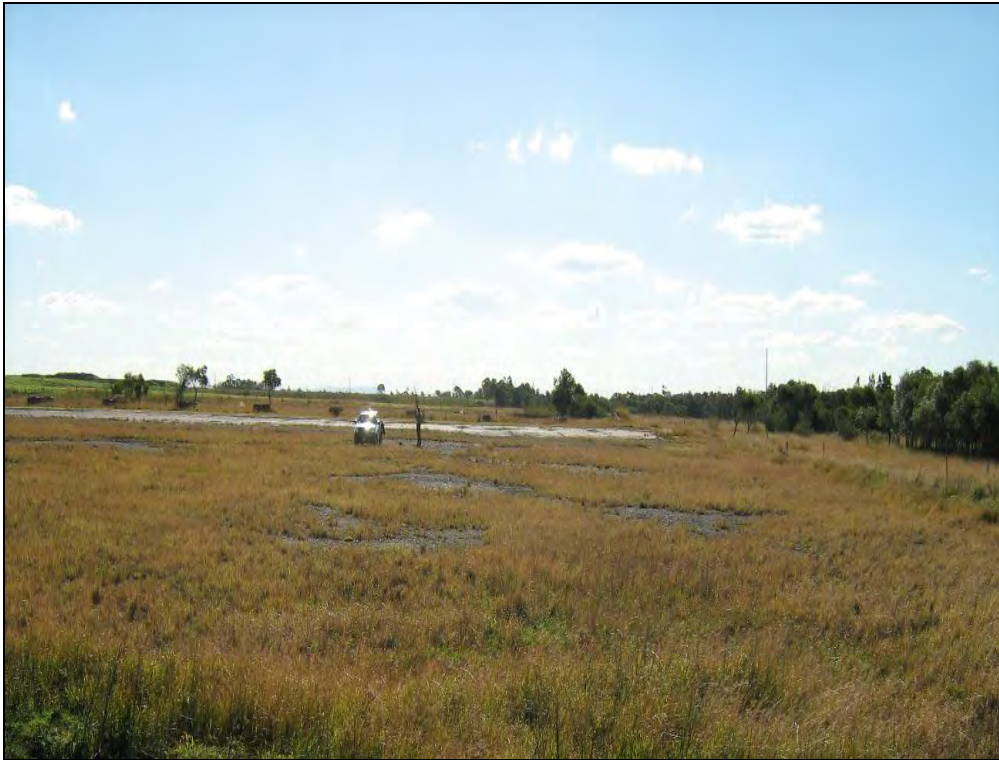
Vegetation in the southern and central portion of the site was observed to be sparse, with sporadic areas of exposed soil/fill (Figure 5). The exposed fill predominantly comprises coal reject material. A salt scald was observed in the central portion of the site (Figure 6), to the north of an elongated fill stockpile adjacent to the drainage channel (Figure 7). Site observations indicate that the stockpile may have been sourced from excavation of the adjacent drainage channel.

**Figure 5: Central portion of site looking north across open grassland with sporadic areas of exposed soil/fill (June 2008)**

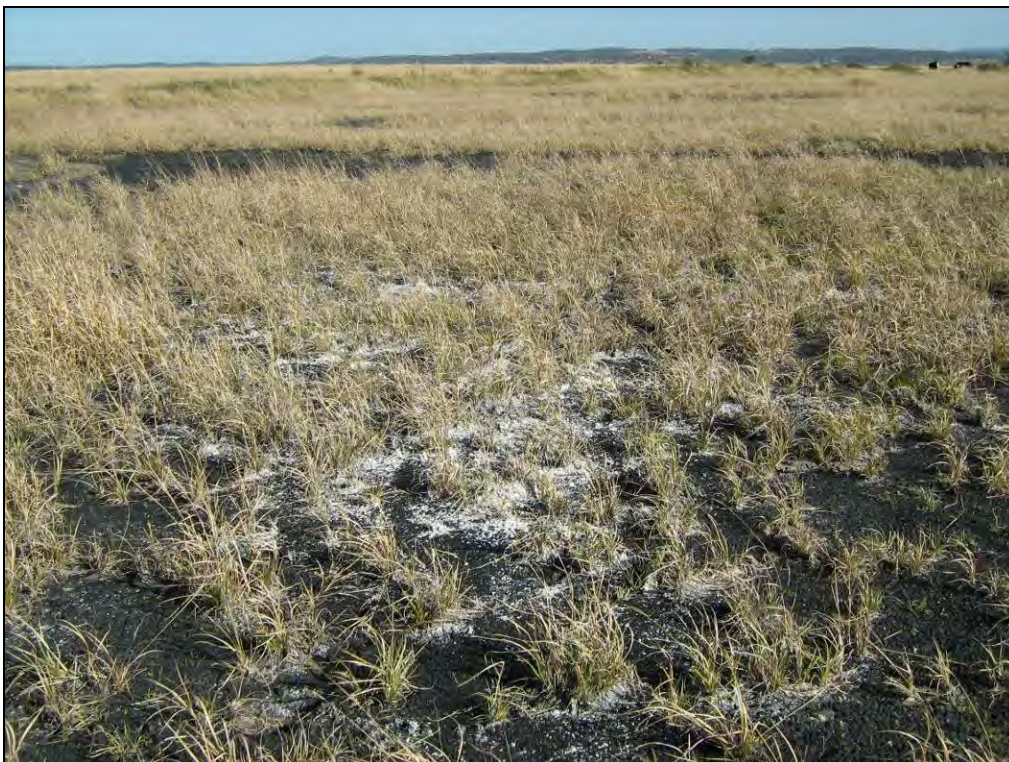
**Figure 6: Salt scald in central portion of site (June 2008)**

Highly sodic soil conditions were found within the majority of samples analysed. The soil within the disposal area should be treated with an appropriate application of gypsum (see attached laboratory report sheets for recommended application rates). Adding gypsum to the soil increases the salinity of the soil moisture without increasing the sodium level, thereby reducing the Sodium Adsorption Ratio (SAR). This will improve the soil structure and reduce the potential for dispersion and erosion.

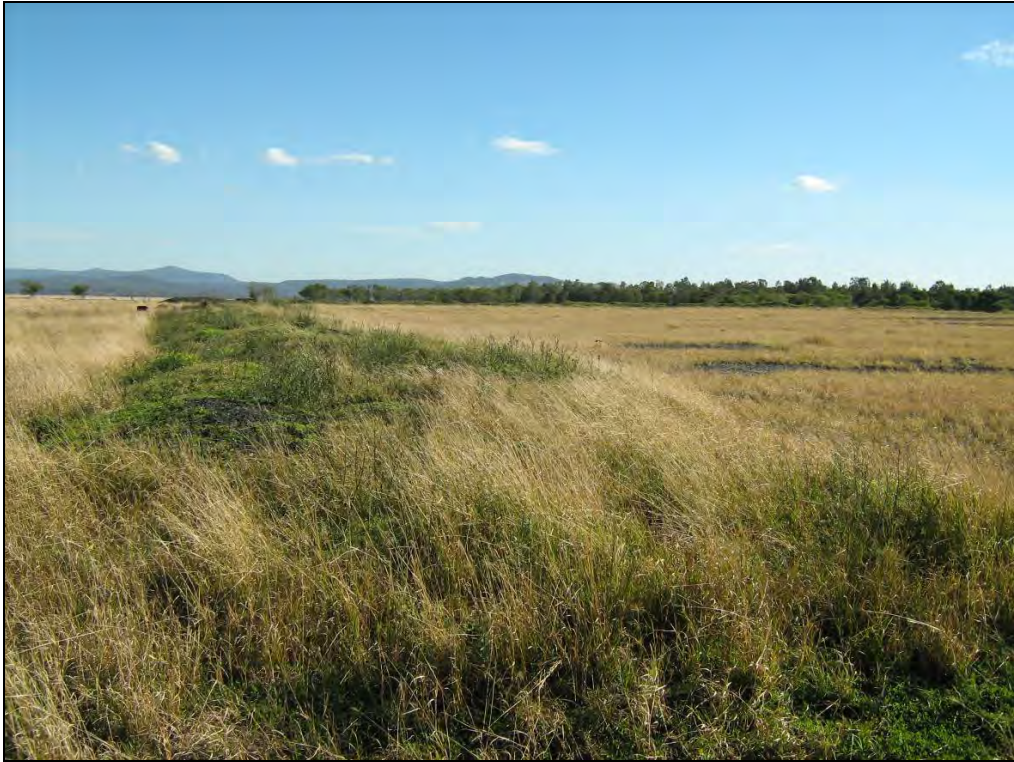
**Figure 7: Elongated fill stockpile to the north of the southern drainage channel (looking west June 2008)**

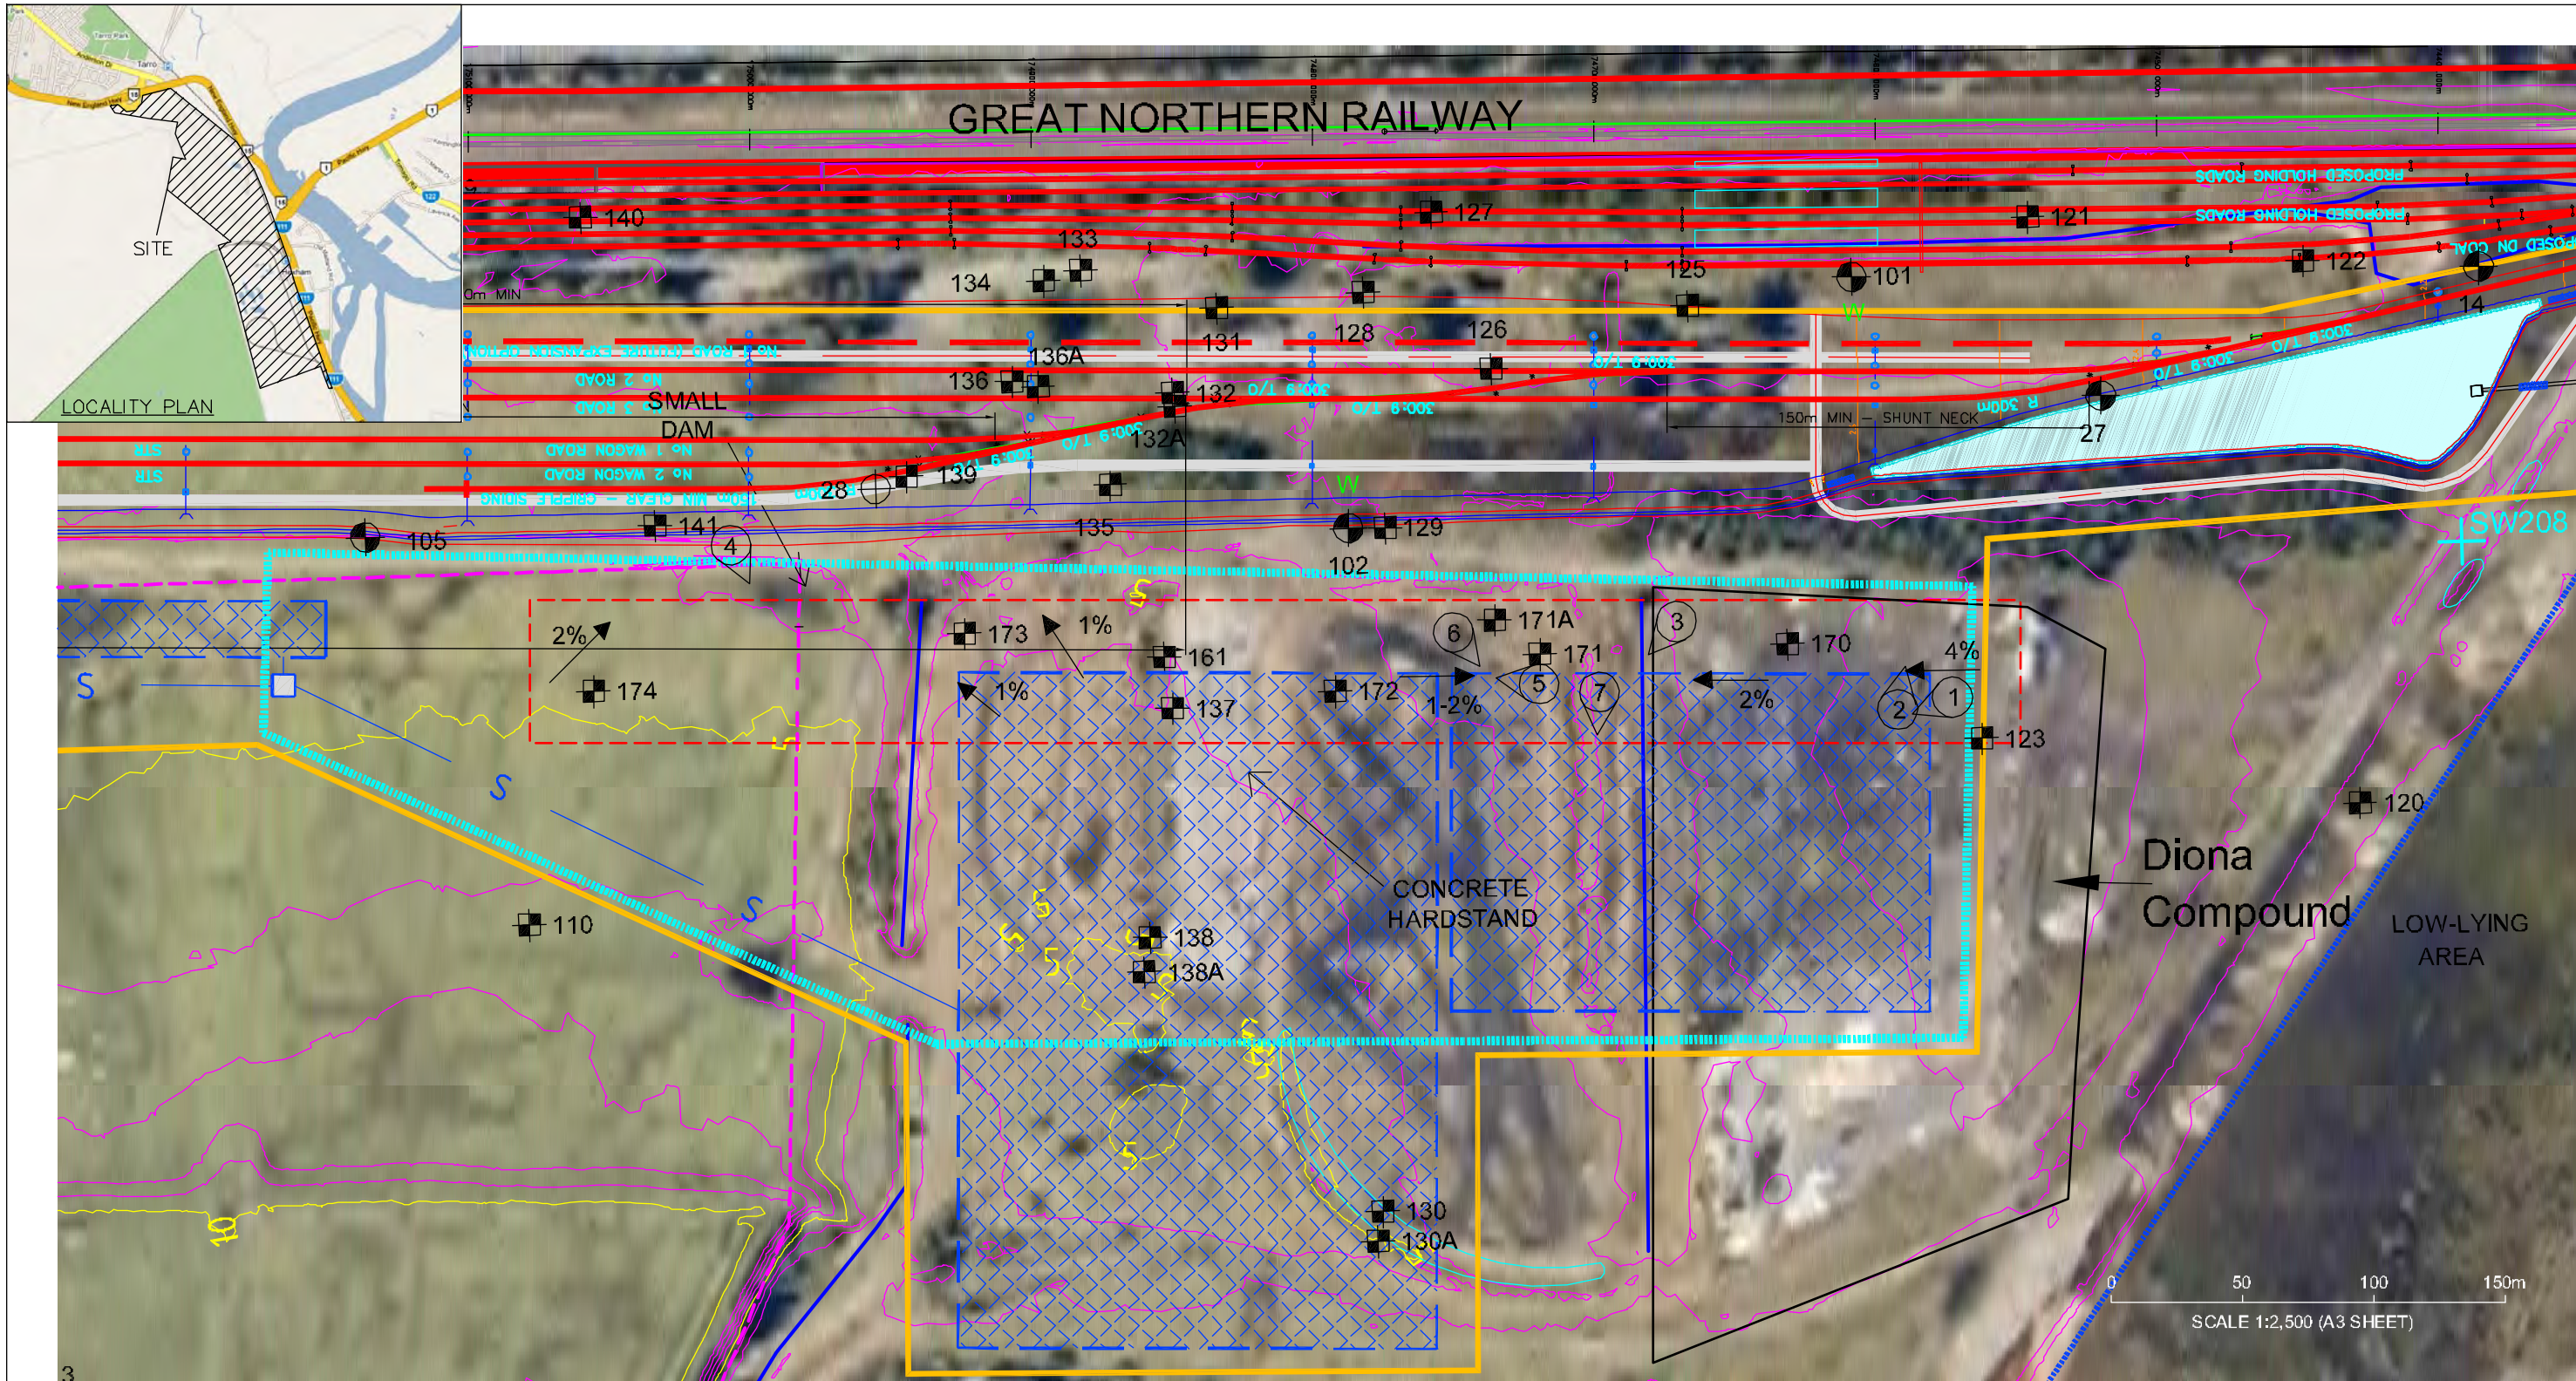
PROJECT No:	39798.07
DRAWING No:	1
REVISION:	1

Refer to Drawing 1 in Appendix C for the site features and locations of photos.
